Inspection Report

Property Address:
123 Somewhere Ave.
Stevens Point, WI 54481

Inspect & Report

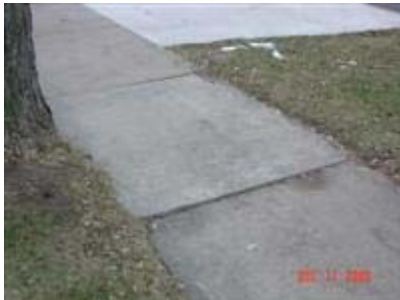
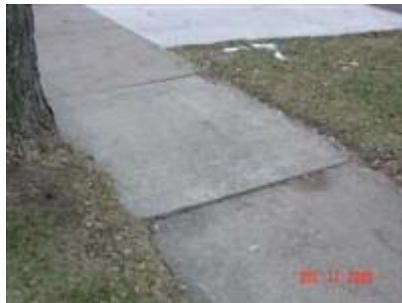
1.1 Picture 1

The sidewalk at the front of home uneven, and can be a tripping hazard. A fall or injury can occur if not corrected. A qualified contractor should inspect and repair as needed.

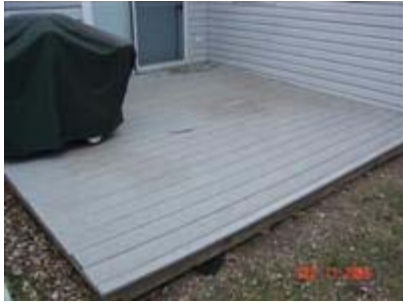
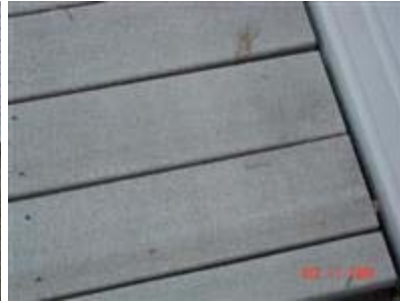
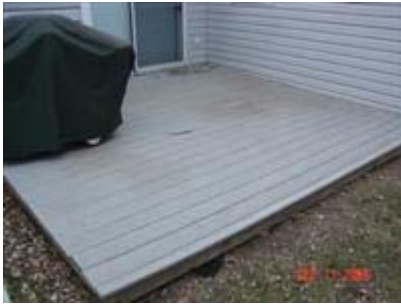
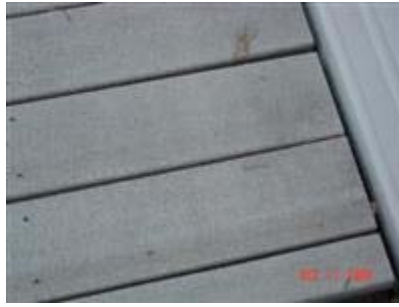
1.5 Picture 1

Deck floor boards are not completely nailed down, ends have not been nailed yet. Finish screwing down floor boards.

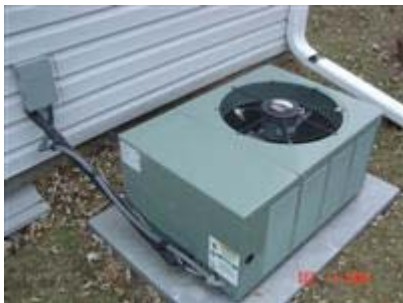
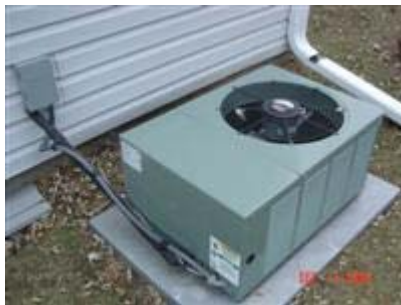
7.4 Picture 1

The A/C was not tested for proper operation due to the outside air temperature is 65 degrees or less. We did not inspect this unit (s).

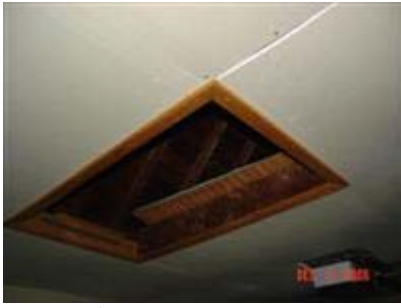
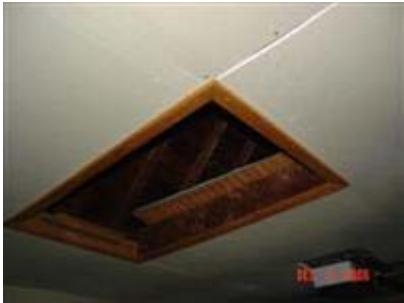
11.1.A Picture 1

The firewall that separates garage from heated space is compromised. The door to the garage attic should also be made of drywall to keep firewall in tact. This is considered unsafe until corrected. A qualified person should correct for safety.

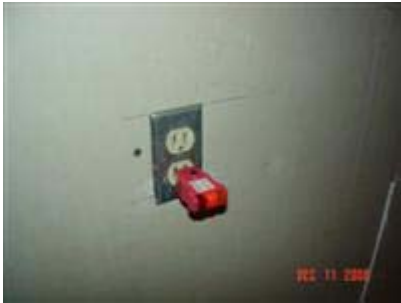
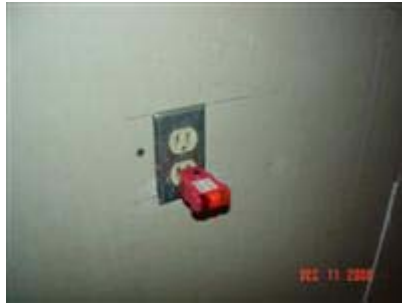
11.7.A Picture 1

Two at the attached garage no GFCI protection. This is a safety issue that needs to be corrected. A qualified licensed electrician should perform repairs that involve wiring.

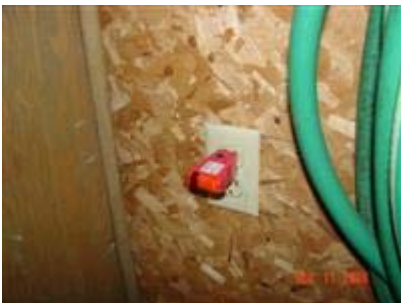
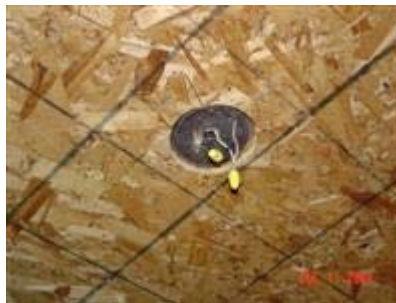
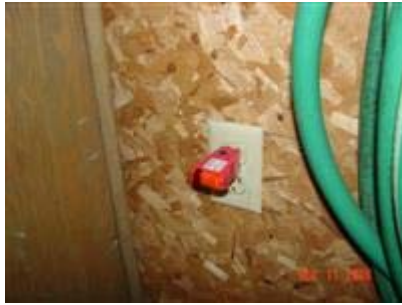
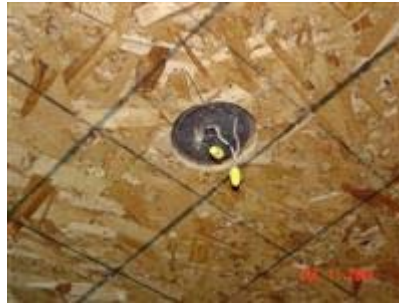
11.7.B Picture 1

All outlets at the detached garage are not GFCI protected. Electrical issues are considered a hazard until repaired. A qualified licensed electrician should perform repairs that involve wiring.

Some ceiling light fixtures not installed yet.

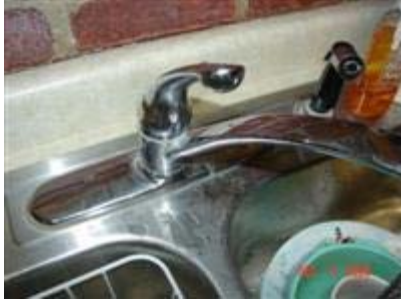
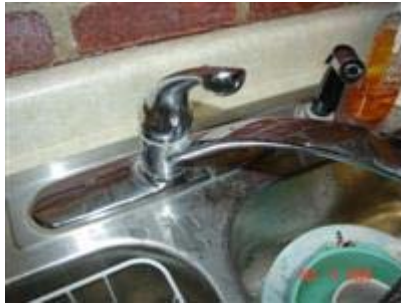
12.0 Picture 1

Kitchen sink faucets leak at spout base when used.

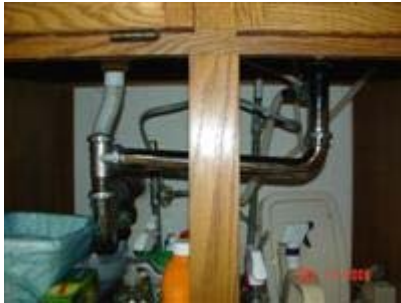
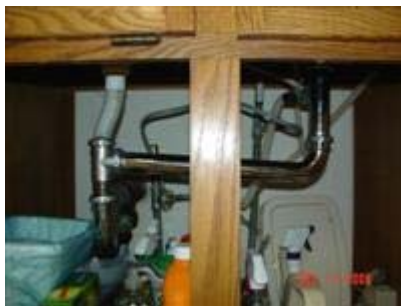
12.1 Picture 1

The waste line has improper slope to drain properly at the Kitchen sink. Repairs are needed so sink continues to drain properly. A qualified licensed plumber should repair or correct as needed.

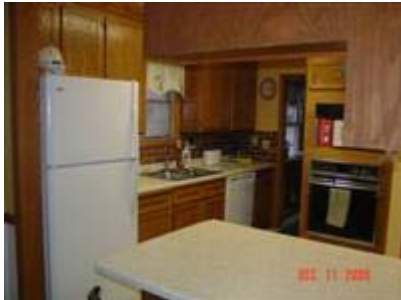
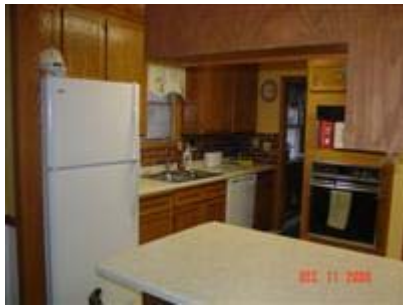
12.2 Picture 1

Countertop is swollen at seam around sink. Counter is almost rotting where it is close to sink, not so strong anymore. Upgrades recommended, repair or replace as necessary.

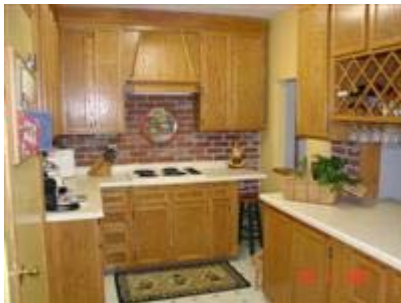
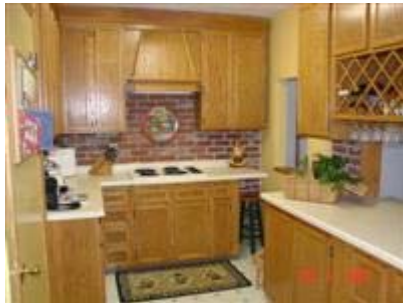
12.4 Picture 1

Cooktop works, but burners do not sit level. May need burner replacement or updating to work properly.

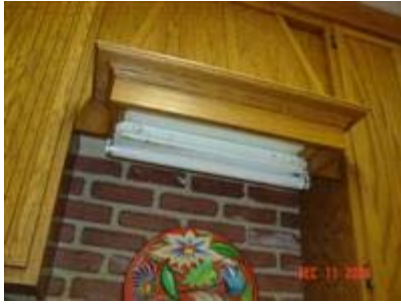
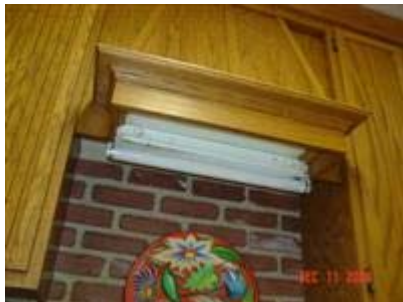
12.5 Picture 1

Range hood is a light only, no fan or exhaust. Updates may be needed.

No exhaust hood or fan over kitchen range. Recommend installing one to remove smell & smoke from cooking.

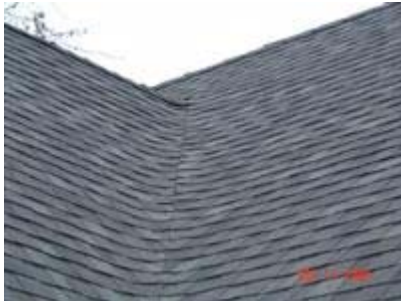
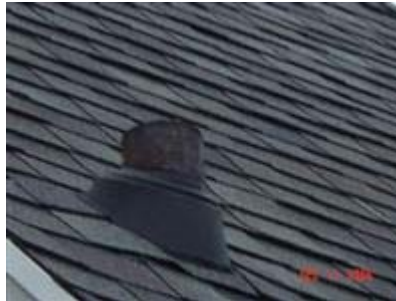
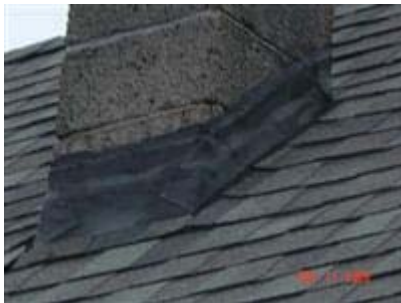
4.0 Picture 1

View of roof shingles, sewer vent flashing, & chimney flashing.

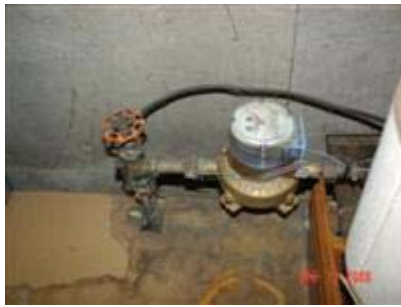
5.0 Picture 1

Water meter & main.

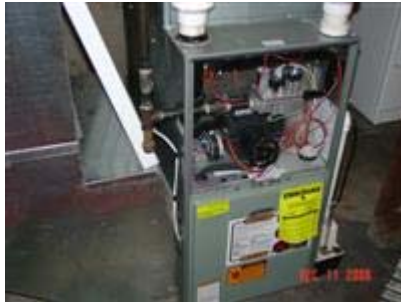
6.0 Picture 1

<input checked="" type="checkbox"/>	<input type="checkbox"/>	<input type="checkbox"/>	<input type="checkbox"/>	<input type="checkbox"/>	<p>6.0 HEATING EQUIPMENT Heat Type: Forced Air Energy Source: Natural gas Number of Heat Systems (excluding wood): One Heat System Brand: RUUD Model # : UGRK-07EMAES, 75,000 BTU, Mfg. 2004 Comments: Ruud gas furnace.</p>
-------------------------------------	--------------------------	--------------------------	--------------------------	--------------------------	--

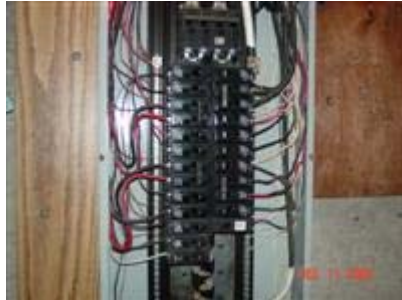
8.2 Picture 1

<input checked="" type="checkbox"/>	<input type="checkbox"/>	<input type="checkbox"/>	<input type="checkbox"/>	<input type="checkbox"/>	8.2 LOCATION OF MAIN AND DISTRIBUTION PANELS Comments: View in main 200 amp breaker box.
-------------------------------------	--------------------------	--------------------------	--------------------------	--------------------------	---

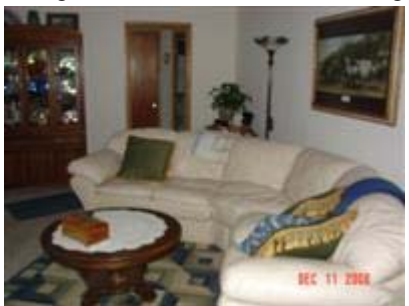
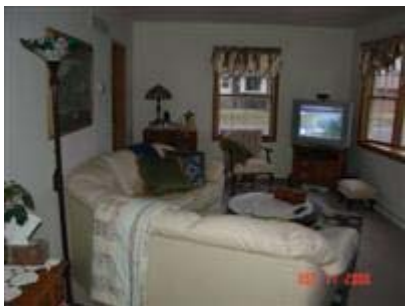
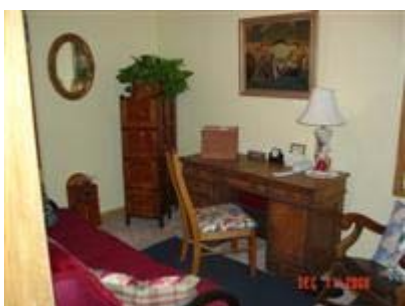
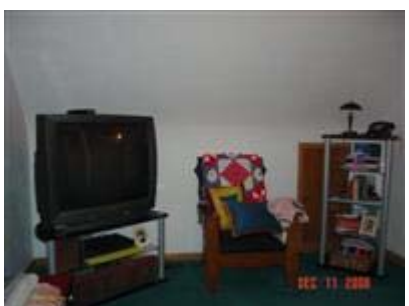
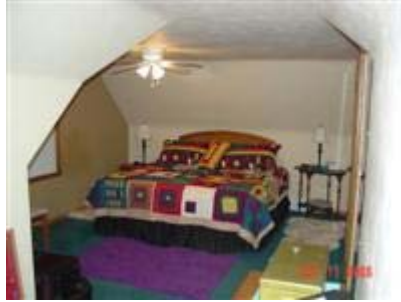
9.4 Picture 1

<input checked="" type="checkbox"/>	<input type="checkbox"/>	<input type="checkbox"/>	<input type="checkbox"/>	<input type="checkbox"/>	9.4 WALLS Wall Material: Plaster Comments: Living room view, office view, sitting area on 2nd floor & master bedroom.
-------------------------------------	--------------------------	--------------------------	--------------------------	--------------------------	--

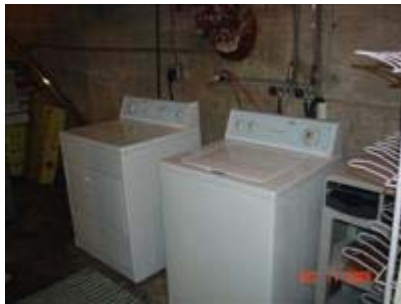
10.3 Picture 1

10.3 LAUNDRY
Comments:
Set up for 240 volt electric dryer.

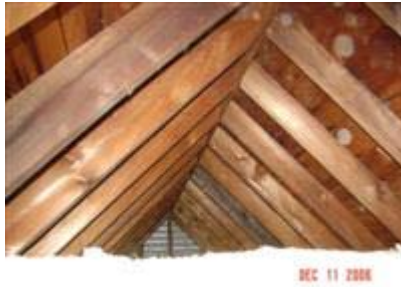
10.6 Picture 1

Comments:
 View of upper main attic with gable end vents.

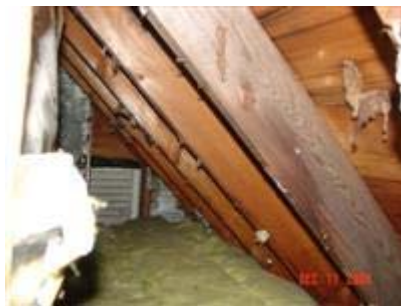
10.8 Picture 1

- 10.8 ROOF STRUCTURE AND ATTIC
Comments:
 View in side attic.

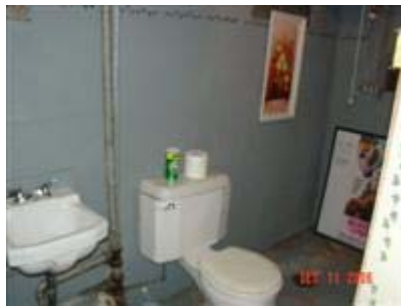
13.0.A Picture 1

13.0.A TOILET
Toilets: Floor mounted
Comments:
 Basement bath.

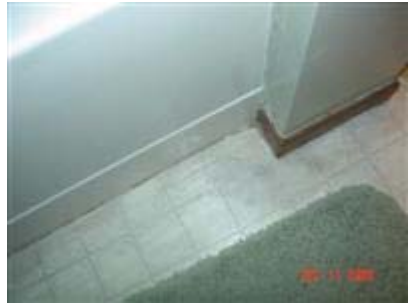
13.0.B Picture 1

Where vinyl floor meets tub in main floor bath, vinyl flooring is stained from past leak.

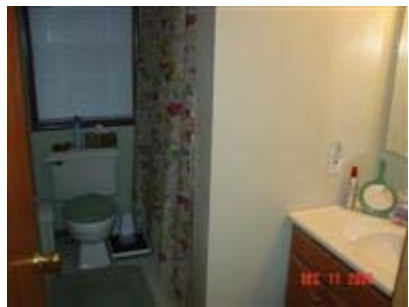
13.2.B Picture 1

Comments:
View of main floor bath.
